Maryland Historical Trust Maryland Inventory of Historic Properties Form

Addendum to Inventory No. M: 26/8 Rose Hill Farm/Bullard Mansion Historic District

This Addendum adds the barn, milk house, and garden to the previously designated Rose Hill Farm/Bullard Mansion Historic District.

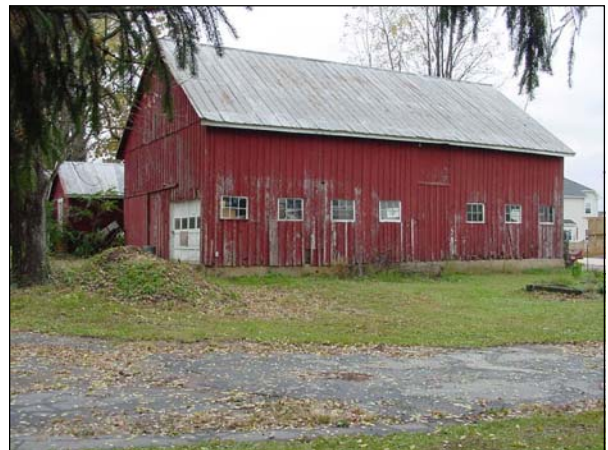
View of barn and milk house from northwest

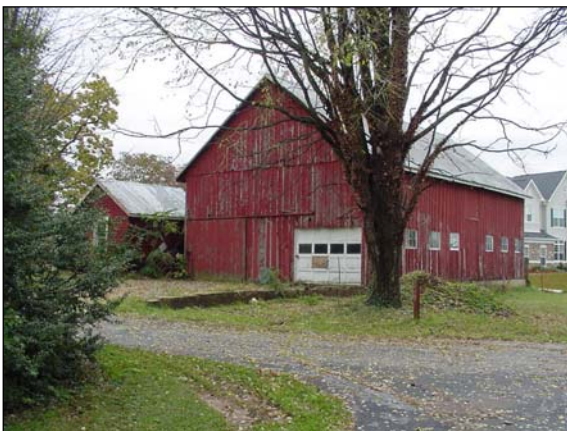
North (main) and west facades

The barn faces north and measures approximately 30 feet wide by 50 feet long. It is three bays wide, with two wide side aisles flanking a narrow center aisle, by four bays long. It is sheathed in vertical board and batten rough-sawn lumber and rests on a poured concrete foundation. The roof, which is covered with standing seam metal sheets, has no chimneys or vents, indicating that it is likely a replacement.

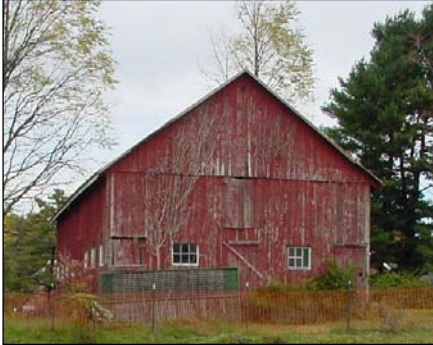
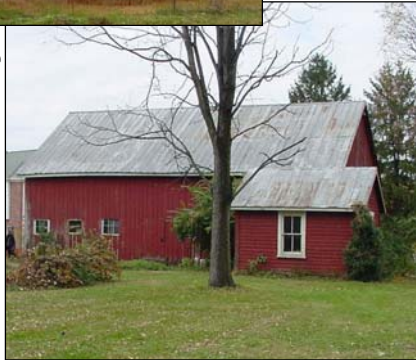
Fenestration in the barn consists of large and small door openings and a number of windows lining the long sides of the building. The windows are all six-pane fixed sashes, some of which are re-used from six-over-six sash windows, possibly from the Rose Hill Mansion or a building on the grounds of the former Chestnut Lodge. The windows are arranged two per bay on each side, except in the second bay from the south, where doors rather than windows are present (main floor door on the east side, hayloft door on the west). The northernmost bay on the east side contains the passageway to the milk house.

**South façade
(top)**

**East façade
(bottom)**

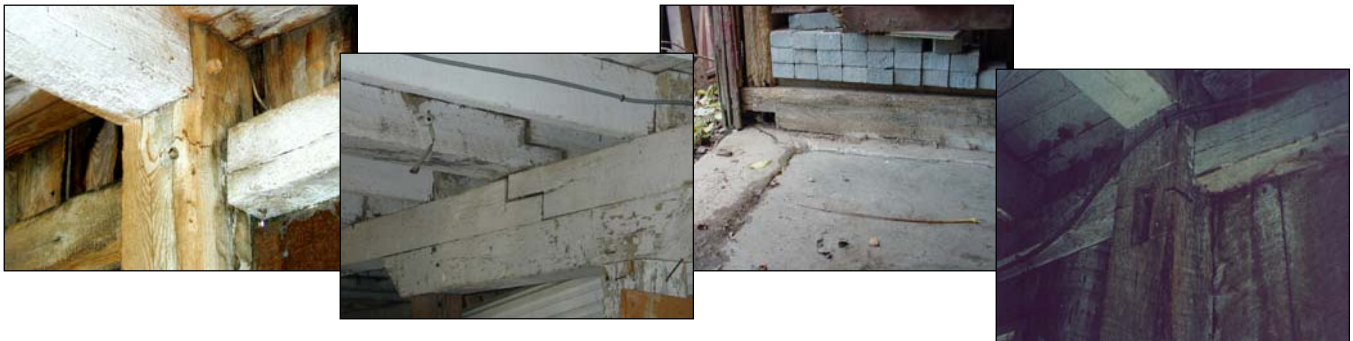
Inside, the structure of the barn is timber frame above the concrete foundation. The sills, posts, and beams are connected by a combination of half notch, nailed, and pegged and unpegged mortise and tenon joinery.

Various internal frame members showing joinery and reuse of timbers. Left to right: Pegged mortise and tenon joint on west wall, notch joints over interior door between aisles, sill plate (reused notched timber) at northeast corner, and a post along the west wall (with exposed mortise).

Many of the members have been reused from an older barn. The newer members tend to be smaller in dimension than the reused hewn timbers. The structure of the hayloft consists of a Queen post truss system, posts continuing from the first floor, corner braces, purlins, and rafters. Most of these members appear to be standard size machine cut lumber.

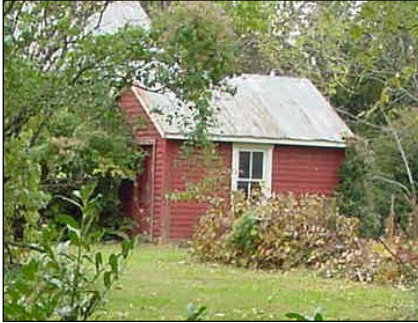
Associated with the barn is a small one-story milk house, which is connected to the barn through a narrow passageway to the east façade at the northeast corner. The passage has a gable roof with a historic paneled door leading into the milk house. The milk house is approximately 15 feet square with a poured concrete foundation. The building has horizontal, rough-sawn weatherboard siding and corrugated metal covering the front gable roof.

Milk house, southeast corner

From the exterior, the milk house is accessed through a six-panel wood door in its south façade. Windows in this small building are a six-over-six double hung sash window on the south façade, a one-over-one wood sash window in the north façade and a two-over-two wood sash window in the east façade. The door and windows are likely re-used elements from the main house. The interior of the milk house has a concrete floor, and concrete walls up to approximately four feet. The upper walls and ceiling are white-washed, beaded tongue-and-groove boards flush on the walls. A concrete trough is located in the floor along the north wall.

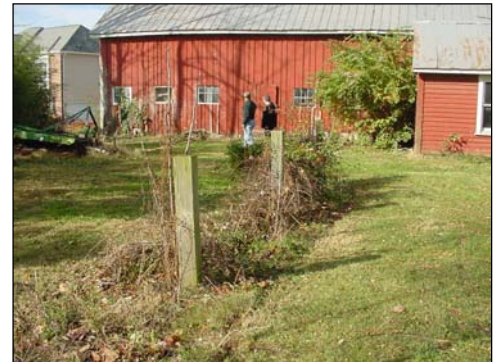
Between the Rose Hill Mansion and the agricultural outbuildings is a landscape rich with horticultural significance. The openness of this landscape reflects the formerly agrarian nature of Rose Hill. Planted here are several mature conifer and deciduous trees, the remnants of a fruit orchard, and grape vines believed to have descended from the earliest Catawba grape cuttings obtained from North Carolina.

Grape vines to east of barn
